Manhole Inspection Summary

Manhole # S41C__056MH

Insp Date: **6/27/08 1:03 PM**

Location Address: **224-238 silver ct**

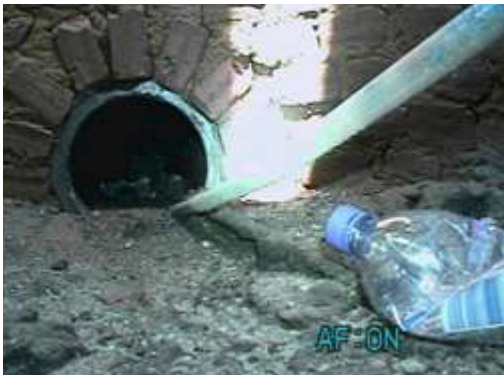
Miscellaneous

channel debris

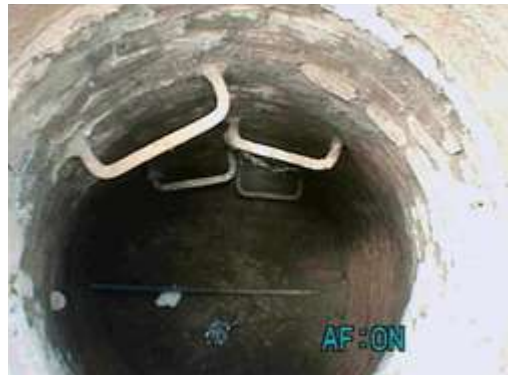
Defect 2

Condition: ☐ Sound ☐ Cracked ☐ Root Intrusion ☐ Loose Brick ☒ **Deteriorated**

Infiltration: ☐ None ☒ **Joint** ☐ Cracks ☐ Mortar ☐ Roots ☐ Wall

Count: **4** Missing: **0** ☒ **Corroded**

corroded steps, signs of infiltration from chimney joint

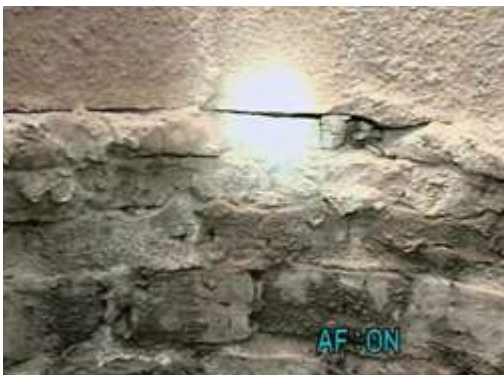
Defect 1

frame adj

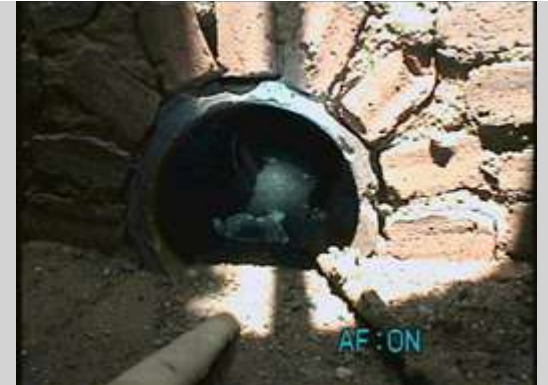
12 O'Clock Outflow

Deposits: ☐ None ☐ Mud ☐ Sludge ☒ **Debris** ☐ Grease

Silt Depth: **2** (in.) Deposits Extent: **Medium**
